# Historic Building Architects, LLC

Re: Burnt Coat Light Station, Swan's Island, ME

2. Light Station Tower Assessment: We were asked to assess the condition of the Light Station Tower comparing the current conditions to our survey in 2006 and have provided a series of annotated photographs. The hope is that this will help the Friends of Swan's Island Lighthouse (FOSIL) to enroll the support needed for the Tower restoration, which is clearly becoming increasingly urgent.

Tower Conditions at  
Swan's Island Light Station

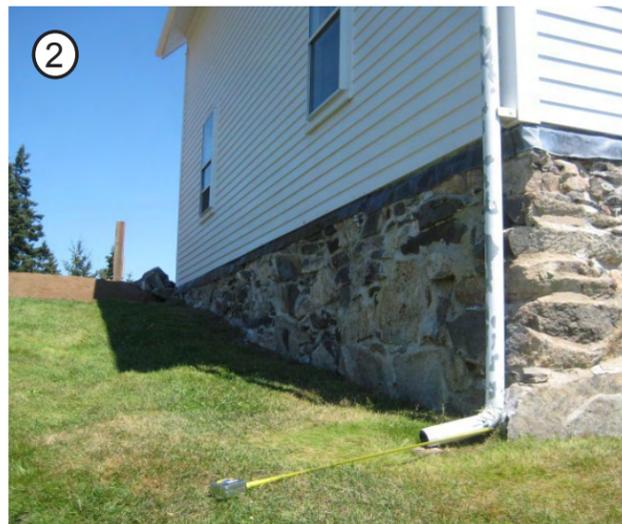
Bottom: Steep grade, at west end of Light Keeper's House.

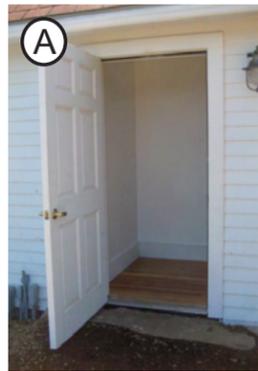
**North Door (D104-A) - Main Entrance**

Originally a window opening ca. 1890 and converted to a door in the 1900s, the Main Entrance Door (D104-A), was replaced with a 6-panel solid wood door in 2010. Remaining historic evidence (Door D102-A) indicates that 4-panel doors were typically used on the first floor of the Light Keeper's House. Though a 4-panel door would have been more appropriate, we do not feel that the 6-panel door detracts from the historic character of the building

given the record of earlier alterations. We defer to MHC to provide an opinion on whether the new door should be replaced. A solid bronze lever handle that will not be pitted by weathering is recommended to operate the door. The frame was severely deteriorated and replaced in 2006, and the door opening widened to provide barrier-free access. An accessible door needs to be at least 2'-8" in width, preferably 3'-0". The existing aluminum threshold, which is not in keeping with the period of significance, is also not barrier-free accessible because of the level change between the threshold and the exterior path. HBA recommends resolving this by installing a new hardwood threshold with a shallow slope for barrier-free access; the threshold should be painted or stained and molded to the exterior stone below. Flashing needs to be installed behind the stone to ensure that the sill plate is properly protected.

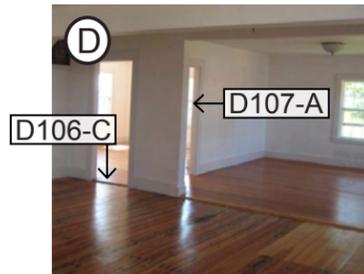
*The first floor of the Light Keeper's House is largely accessible. However, there is a sloped threshold from the Public Meeting Room into the Parlor at Door D106-C (Threshold B); this threshold needs to be replaced with an accessible wood threshold.*

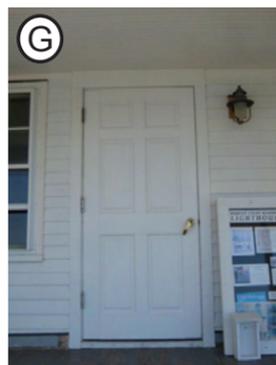
**Piazza Entrance Door (D101-A)**

This door was replaced in 2010 with a 6-panel solid wood door. The previous door in this location, as noted in Section 5, page 3 of the Preservation Plan was a 6-panel door with 3 glazing units in the top panel. The door frame and threshold were all in poor condition, and it is suspected that the door was not the original to this opening. Similar to D104-A, we believe the 6-panel solid wood door does not detract from the architectural significance of the building since no evidence can be found that the original was a 4-panel door. MHC should provide an opinion on whether this door should be replaced with a 4-panel door similar to the Door D102-A. The hardware should be replaced, as described above for D104-A. The threshold is aluminum (photograph H) and does not provide barrier-free access because of the existing level change of 1 1/2". The floor deck of the Piazza needs to be temporarily removed to provide access for framing repairs below. At that time, we recommend raising the Piazza wood floor and installing a painted or stained wood threshold to allow for barrier-free access. See Drawing A 1.4.

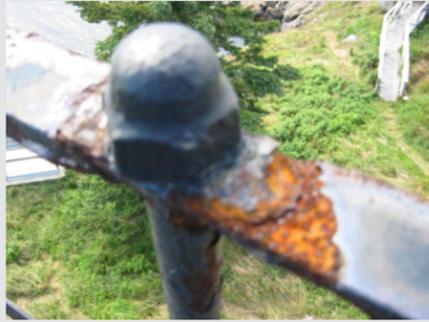
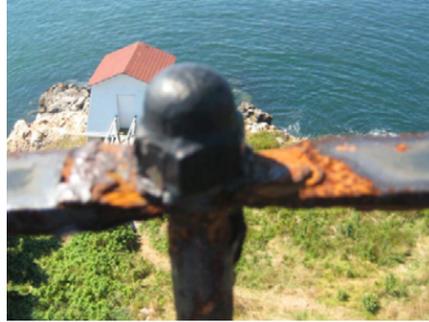
Tower Baluster

Corrosion and rust jacking increased.

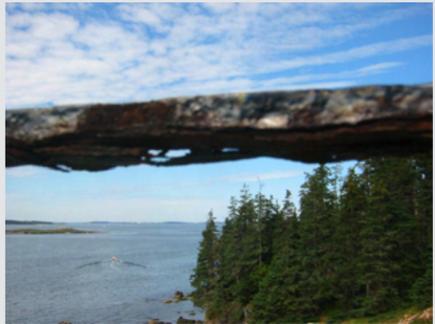
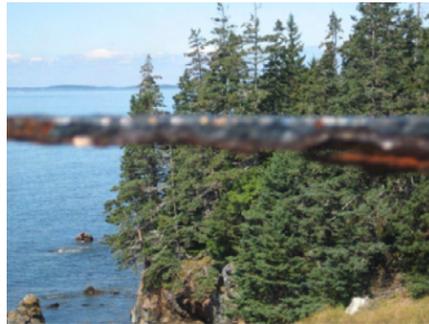
Tower Top Railings

Loss of metal cross-section due to corrosion making railings unsafe.

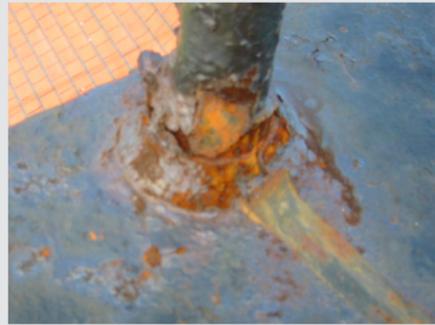
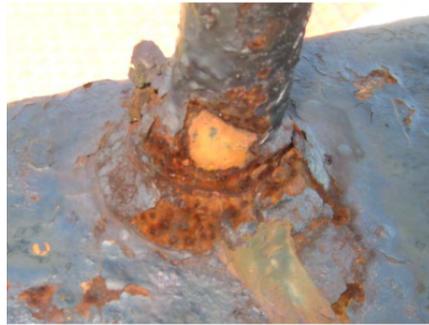
Baluster Base

Corrosion at base of post increased and could result in post and railing failure.

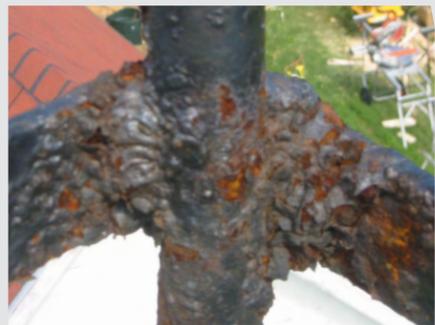
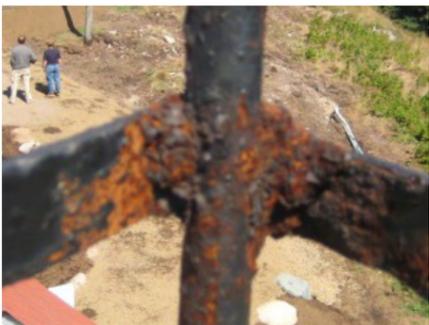
Bottom Rail Junction

Significantly increased corrosion at welded connection.

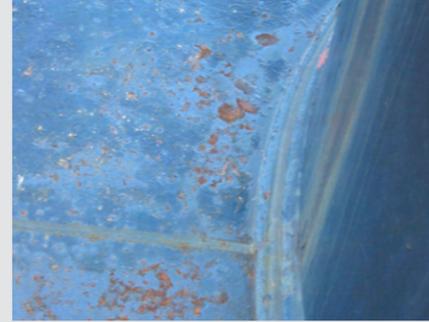
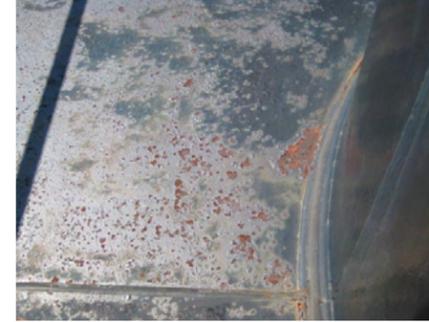
House Platform

Top of deck has significant loss of paint and increased corrosion.

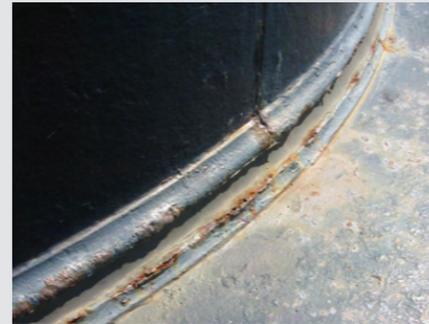
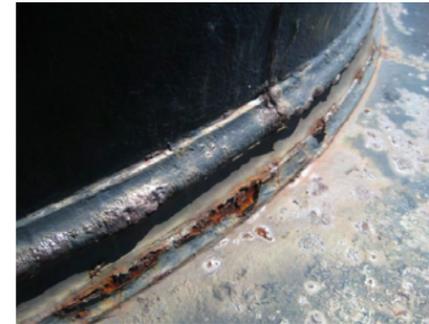
Lantern Base at Platform

Base of lantern drum showing signs of increased corrosion.

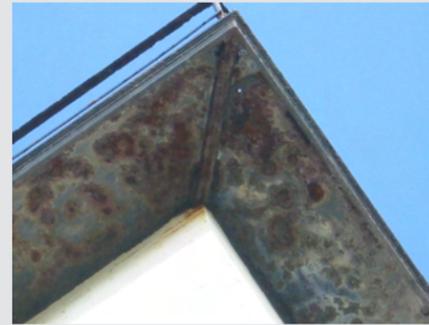
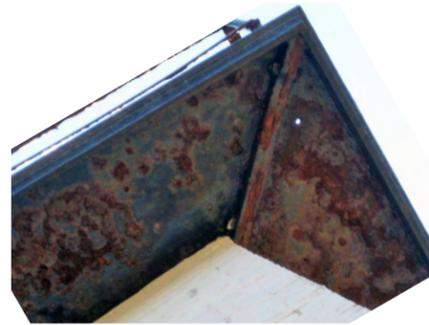
House Platform from below

Significant increase in rust on underside of walkway deck.

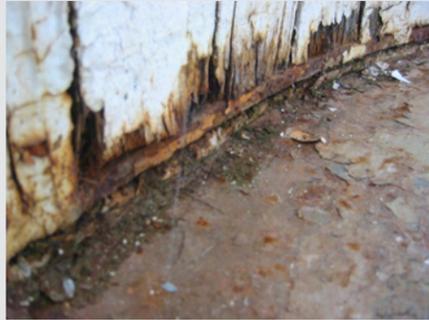
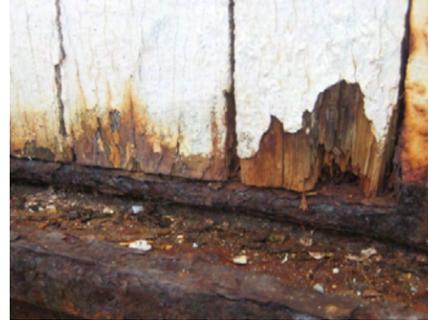
Interior Tower Lantern

Interior base of light where heavy condensation build up has significantly increased wood rot at base and corrosion of metal deck with water dripping onto the floor below.

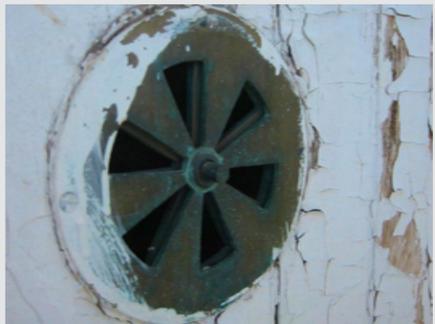
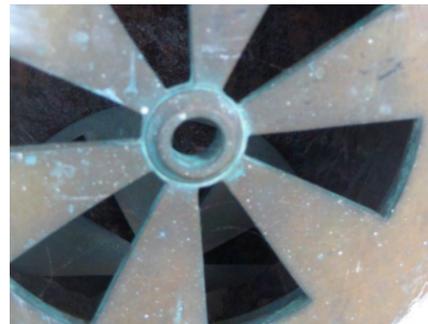
Lantern Vent

Vents are no longer operable resulting in increased condensation causing wood rot.

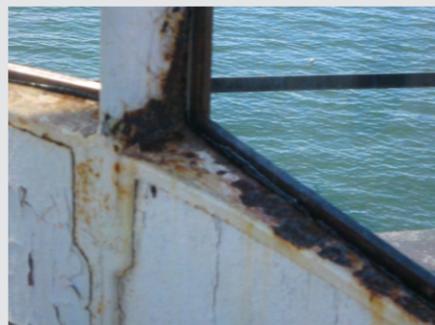
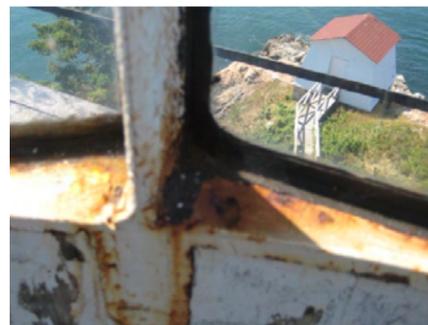
Interior Lantern Glass

Severe corrosion and moisture buildup at lantern drum due to condensation.

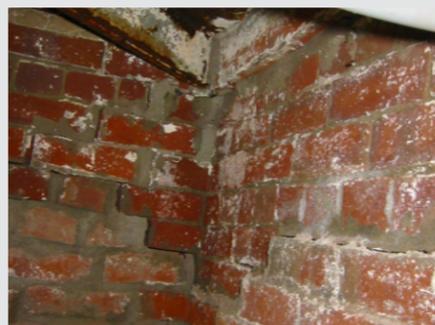
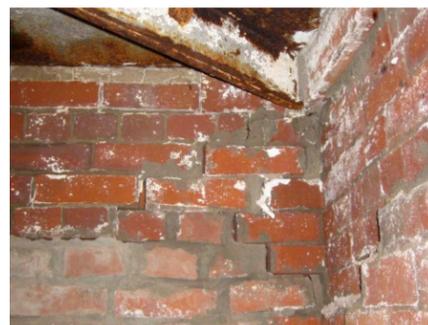
NW Interior Corner of Tower

Masonry cracking at corners appears to be increasing as metal deck continues to corrode and cause rust jacking.

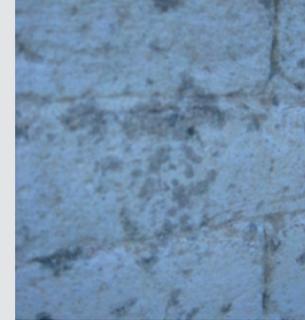
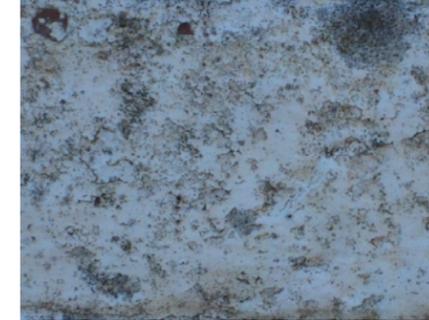
Tower Brick Exterior Wall

Significant increase in exterior biological growth causing paint to fail and moisture ingress.

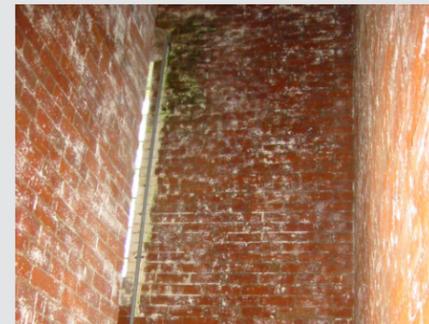
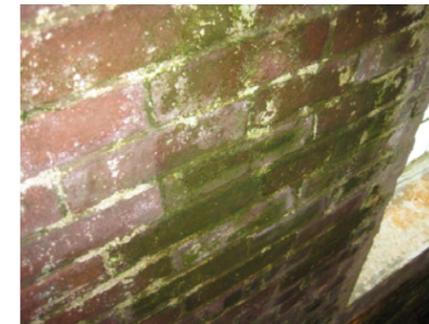
Interior Tower Brick at Window

Significant increase in green biological growth due to lack of ventilation and increased moisture ingress.

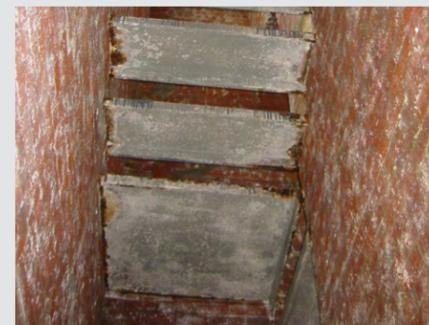
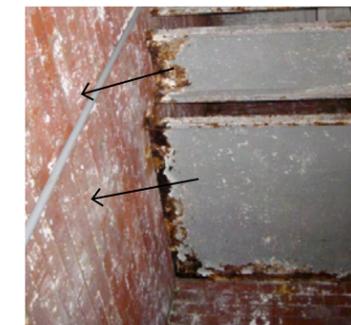
Underside of Interior Staircase

Stair corrosion increased and causing masonry to continue to bulge outward due to rust jacking.
