HAZARDOUS MATERIALS IDENTIFICATION REPORT

***SWAN'S ISLAND LIGHT HOUSE COMPLEX
SWAN'S ISLAND, MAINE***

Town of Swan's Island
Swan's Island, Maine 04685

Summit Environmental Consultants, Inc.
8 Harlow Street, Suite 4A
Bangor, ME 04401

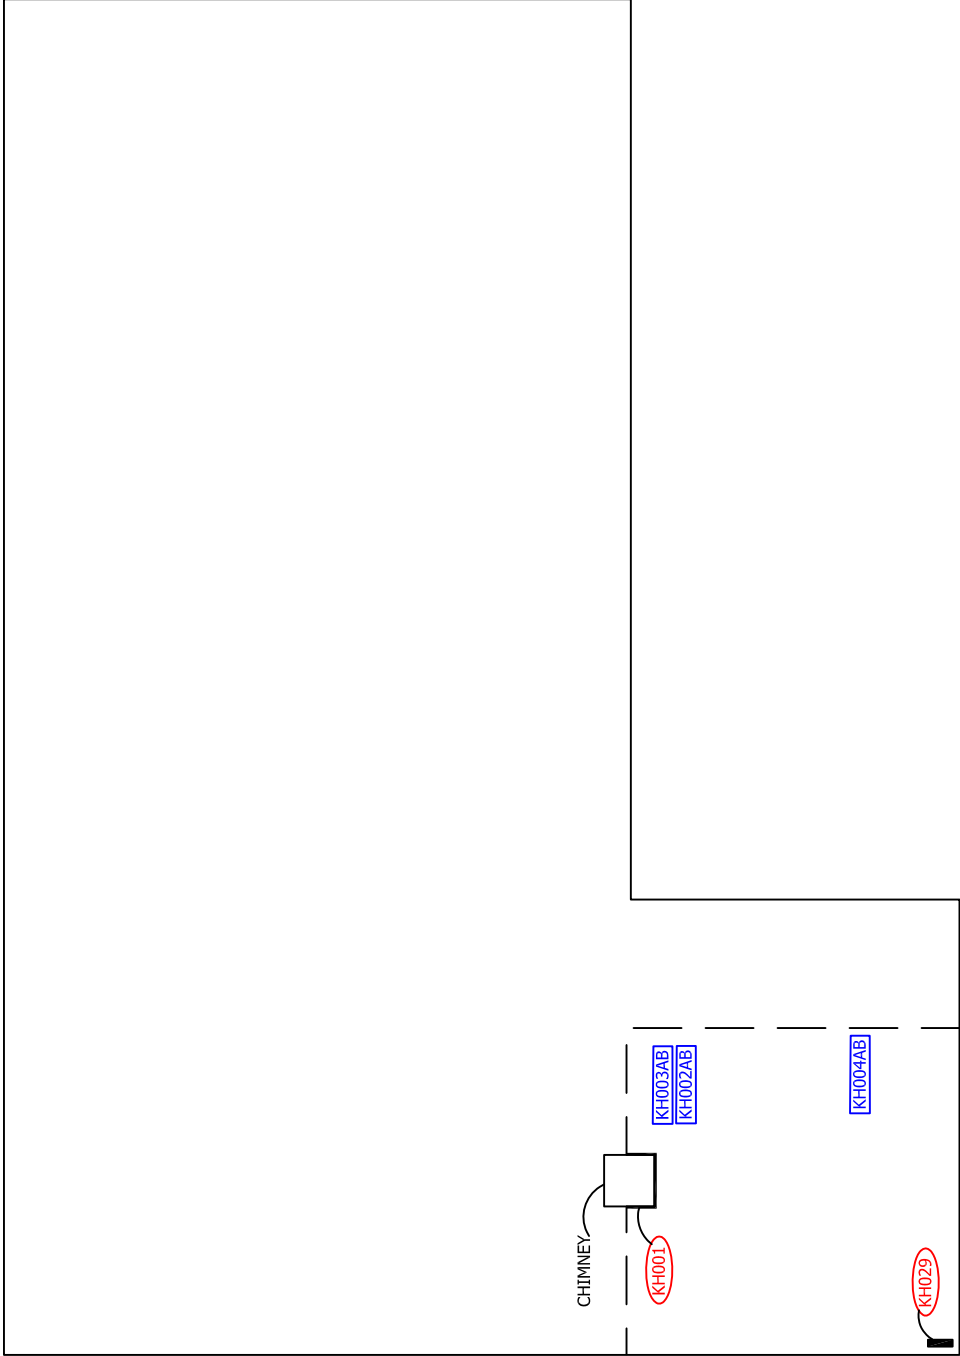
- 9x9 gray mottled floor tile and associated adhesive located on plywood sub-flooring in Bedrooms 1 and 2. (Sample KH007, KH008, respectively);
- 9x9 red mottled floor tile and associated adhesive located on plywood sub-flooring in the second floor Bathroom. (Sample KH013, KH014, respectively);
- Cement gasket material in the Basement. (Sample KH001); and
- Cementitious wall board located around the chimney wall (and one loose board) in the Basement. (Sample KH029).

Locations of identified ACM are presented on Figures 1 through 3. An inventory of ACM identified in the Keeper's House is included in Table 1. Cost estimates (as presented in Table 1) have been prepared to provide a budget for removal of identified ACM. These estimates do not include material replacement costs, regulatory agency notification fees or a contingency. Estimates assume the Contractor will be responsible to prepare the asbestos abatement design(s). Regulatory agency notification fees associated with this project will vary depending phasing and project schedule. Actual abatement costs may vary depending upon the quantity of ACM abated and abatement methods utilized.

Regulations require that identified ACM which may be impacted by planned renovation/demolition activity be removed by a MEDEP licensed asbestos abatement contractor in accordance with applicable state and federal regulations prior to disturbance by such planned activities. In accordance with 40 CFR 61, *National Emissions Standards for Hazardous Air Pollutants* (NESHAP), and 06-096 State of Maine, Department of Environmental Protection, Chapter 425, Asbestos Management Regulations (effective date: May 29, 2004), a contractor conducting any renovation and/or demolition activity that would disturb regulated ACM must: (1) notify the U.S. Environmental Protection Agency (USEPA) Administrator and the MEDEP of such activities, (2) use proper removal procedures, (3) use proper engineering controls to limit emissions of asbestos fibers, and (4) utilize proper waste disposal. If any hidden suspect ACM (behind walls, in chases, above permanent ceilings, etc.) is uncovered during renovation or demolition activities, work must be stopped and the material tested for asbestos content. All ACM must be disposed of in accordance with all applicable state and federal requirements.

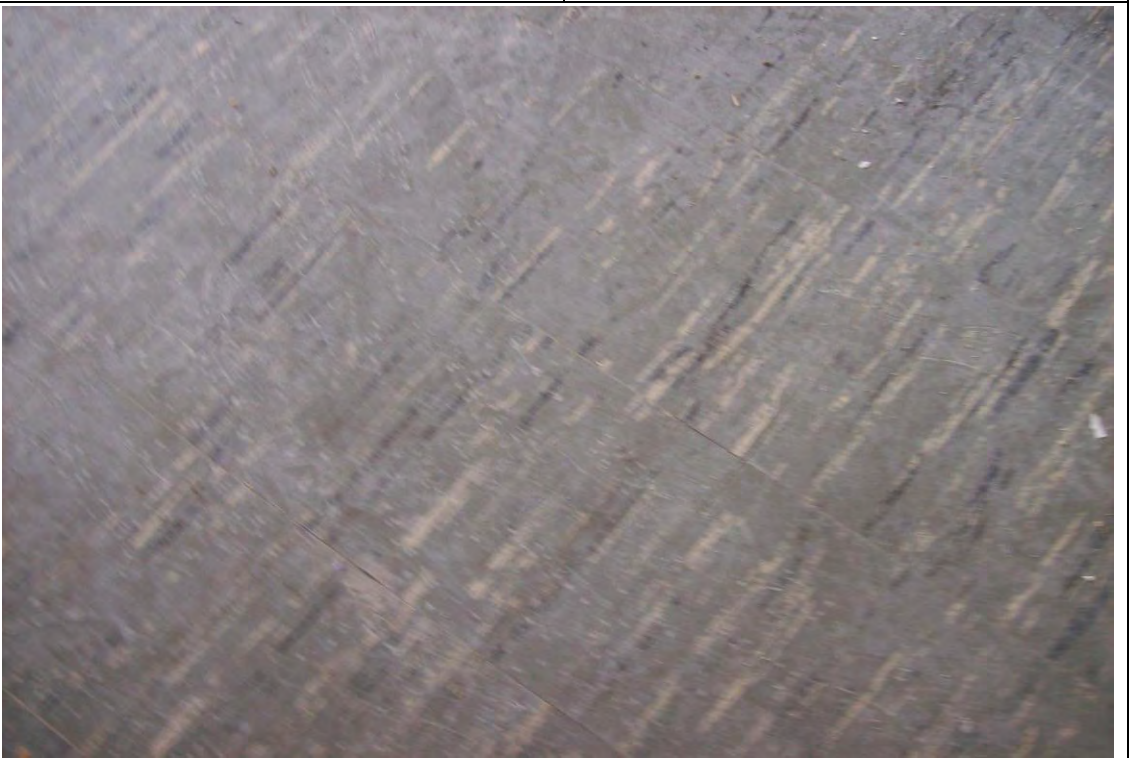
Client Name: Town of Swan's Island		Project No. 13-3055
Photo No. 3

Date: April 8, 2013		
Site Location: Swan's Island Light House		
Description: Keeper's House Second Floor ACM 9-inch by 9-inch Gray Mottled Floor Tile and associated adhesive

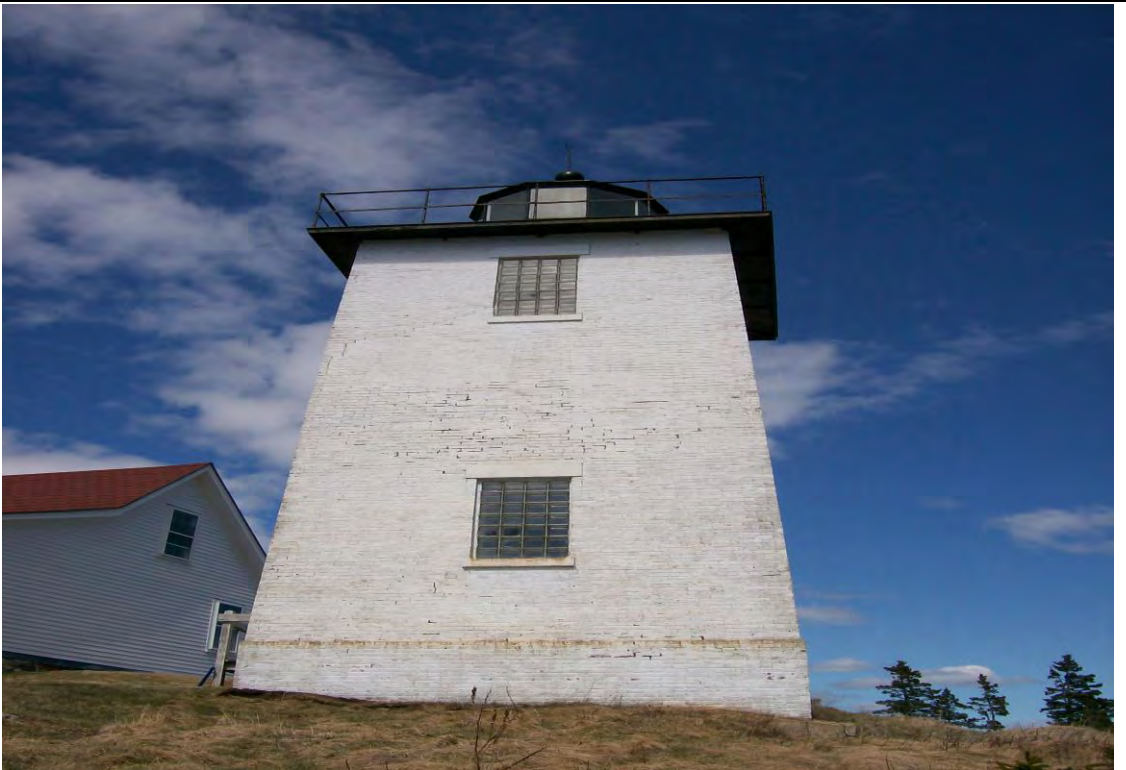
Client Name: Town of Swan's Island		Project No. 13-3055
Photo No. 1

Date: April 8, 2013		
Site Location: Swan's Island Light House		
Description: Lighthouse Exterior Lead-Based Paint Platform & Associated Components

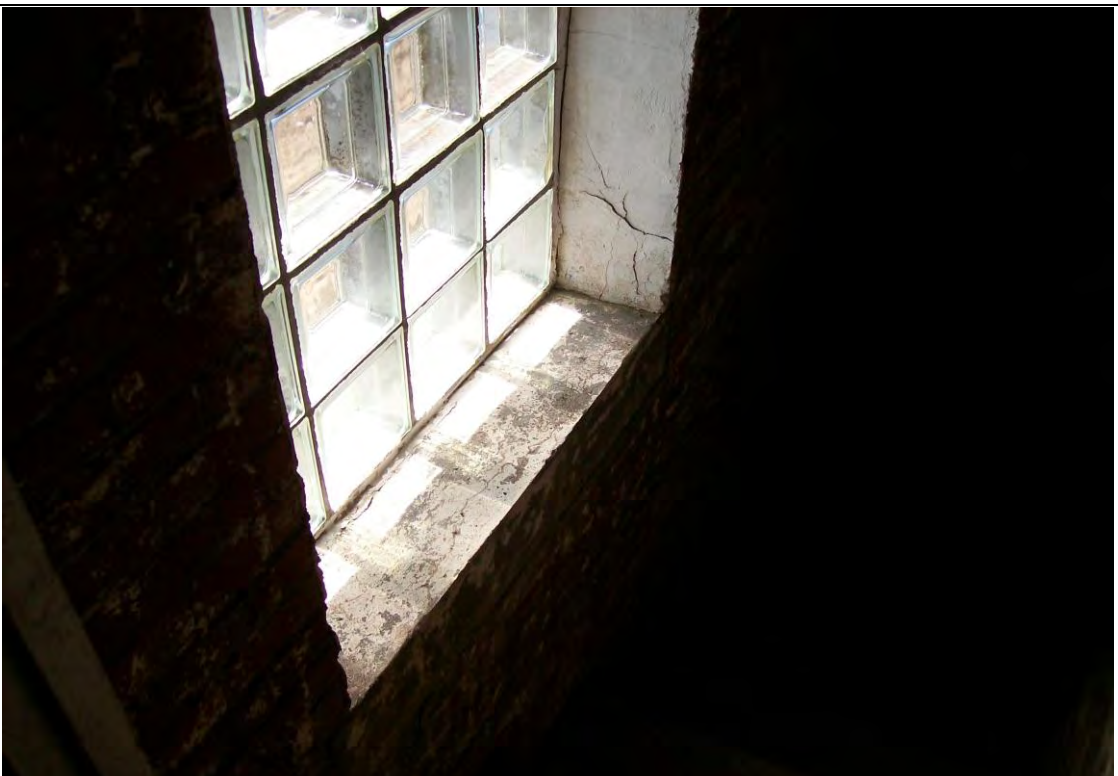
Photo No. 4

Date: April 8, 2013	
Site Location: Swans Island Light House	
Description: Lighthouse Interior Lead-Based Paint Deteriorated paint on masonry frame (note: residual paint on brick does not contain lead)

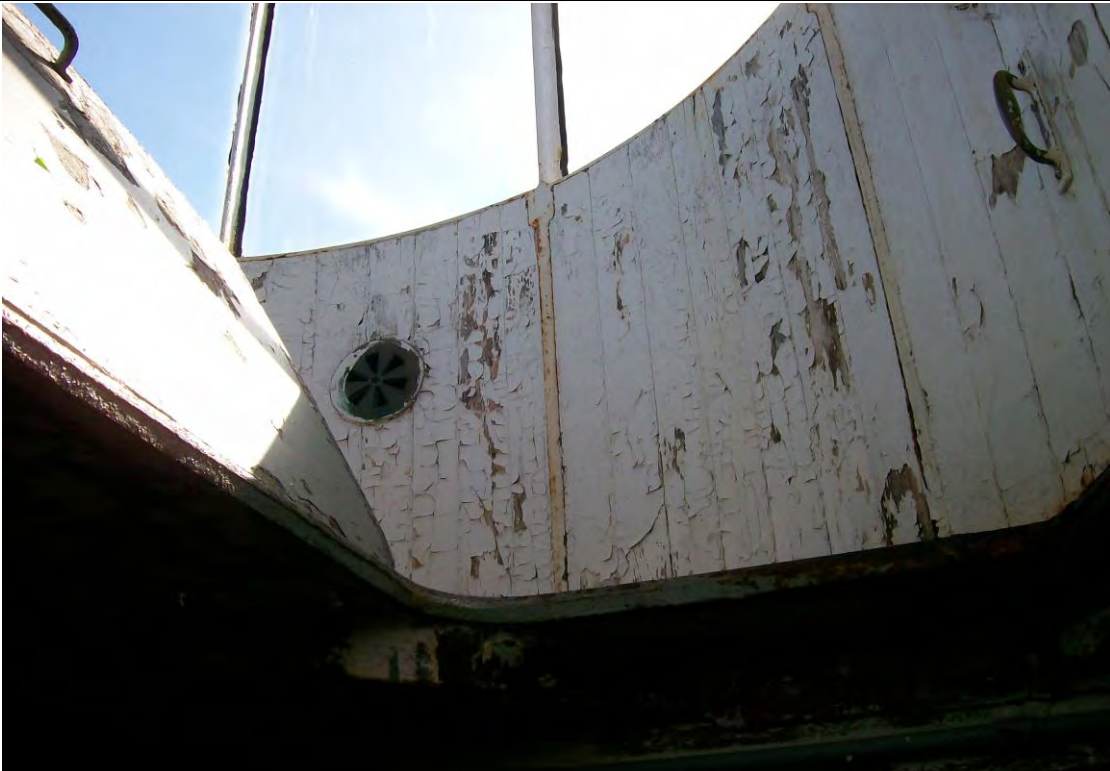
Photo No. 6

Date: April 8, 2013	
Site Location: Swans Island Light House	
Description: Lighthouse Interior Lead-Based Paint Lantern Walls (wood)

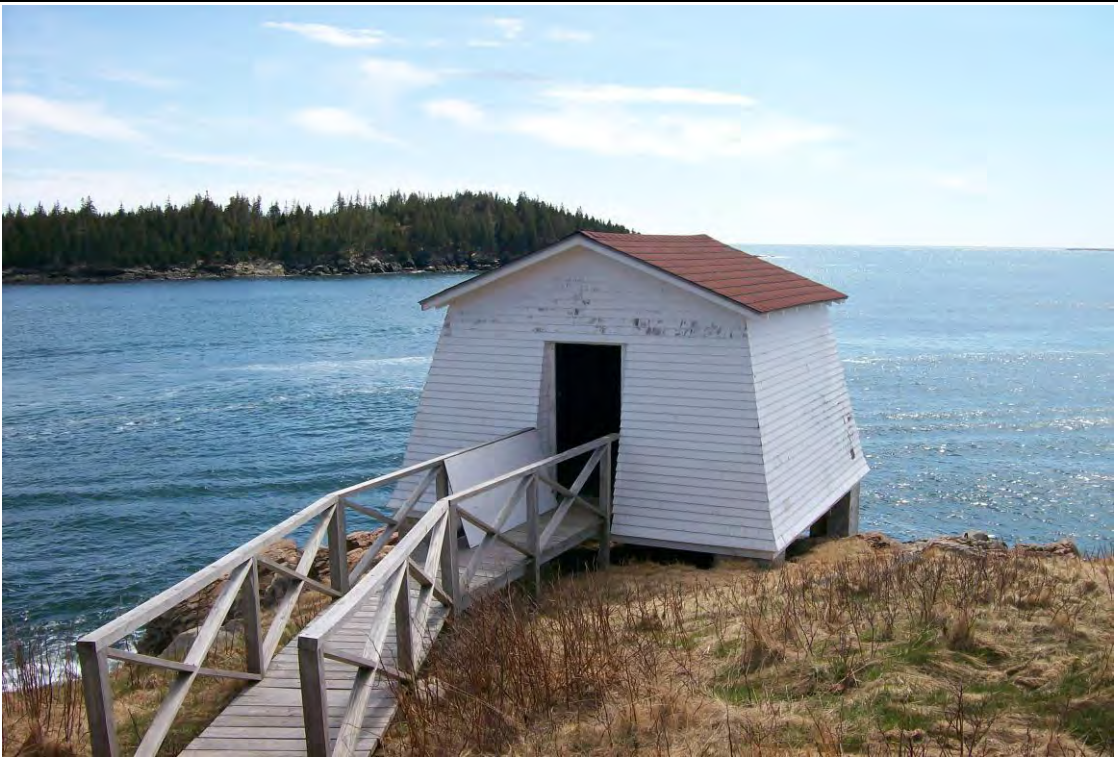
Client Name: Town of Swan's Island	Project No. 13-3055
Photo No. 3

Date: April 8, 2013	
Site Location: Swan's Island Light House	
Description: Bell House Exterior Lead-Based Paint Entry Door Jamb

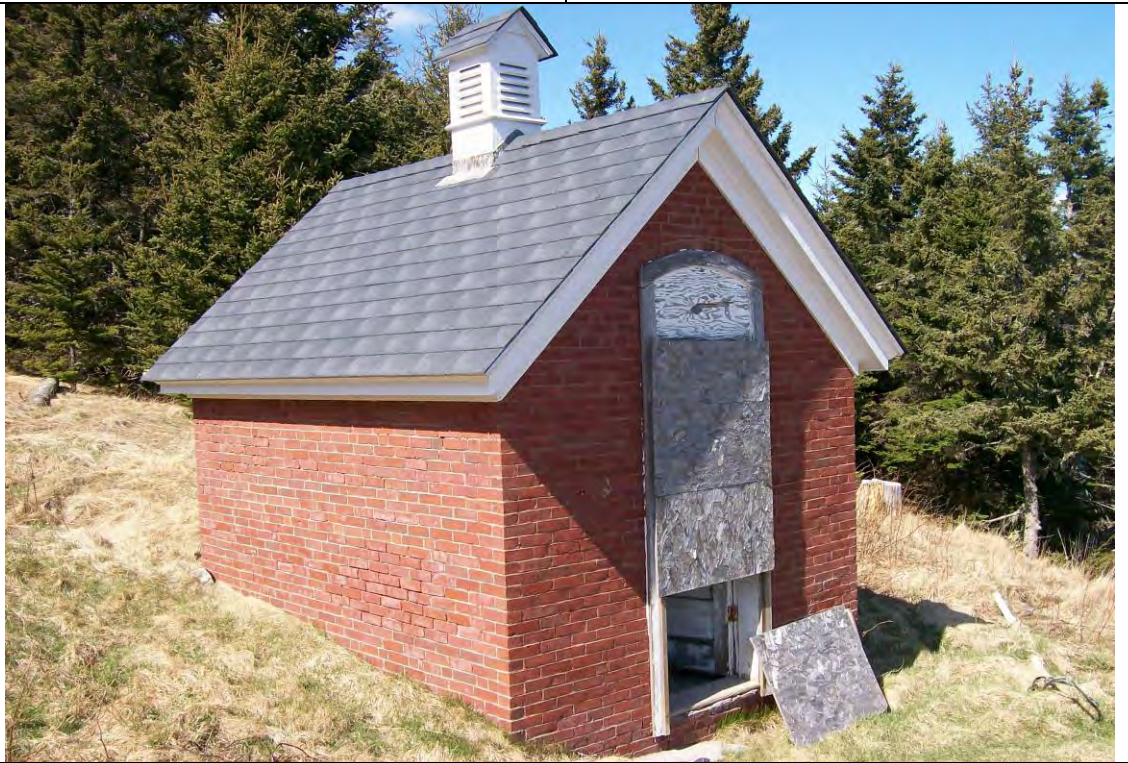
Oil House
Exterior
Lead-Based Paint

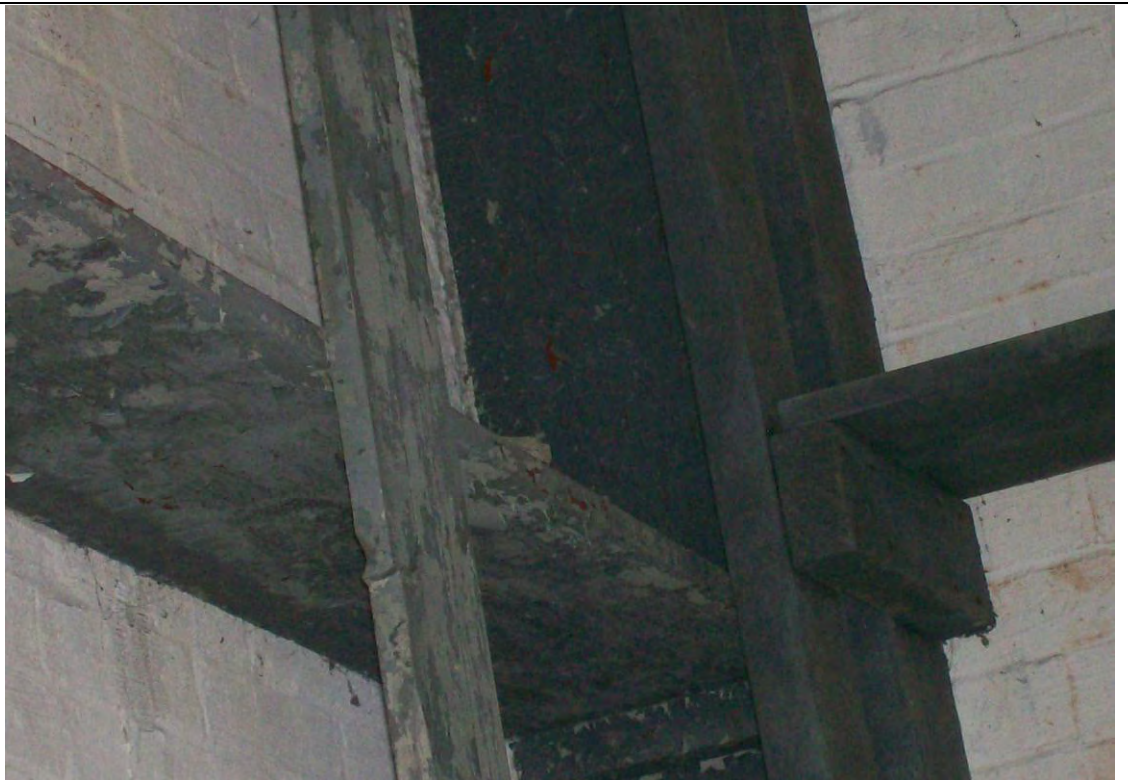
Oil House
Interior
Lead-Based Paint
