PHOTO REPORT ON PHASE 1 OF THE RESTORATION OF THE LIGHT TOWER OF THE BURNT COAT HARBOR LIGHT STATION, SWAN'S ISLAND, MAINE

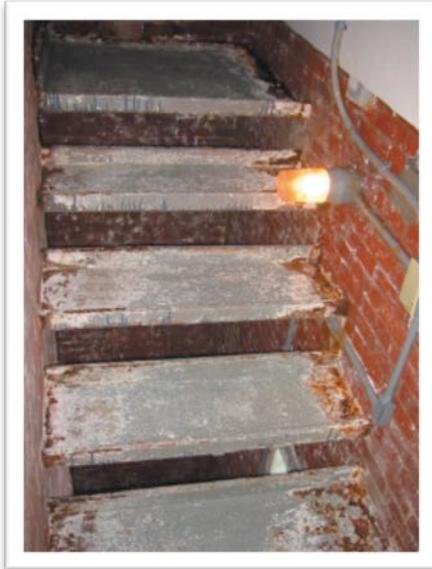
The 34 metal stairs leading to the top of the tower were badly rusted and contaminated with lead paint. There was lots of rust where the stairs were set into the masonry.

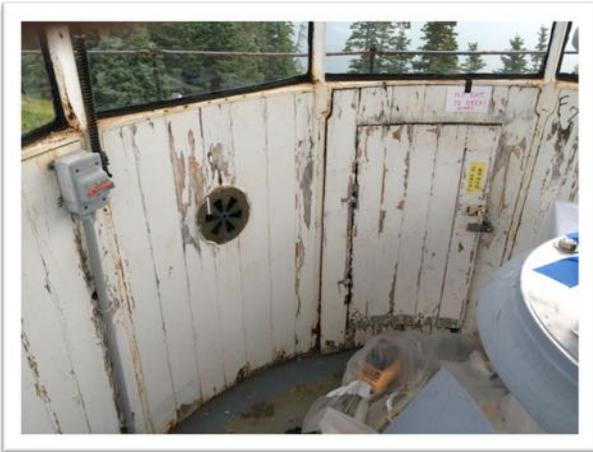
The wall below the windows in the cupola was lined with wooden wainscoting. The wainscoting had to be removed and repaired. The metal wall behind the wainscoting had serious rust. All was contaminated with lead paint.

Detail at base of wainscoting showing damaged wood and rusted metal

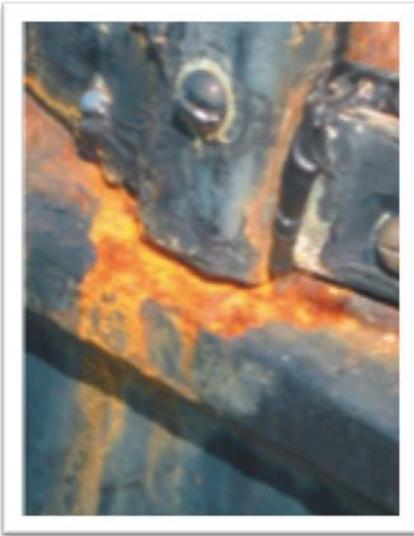
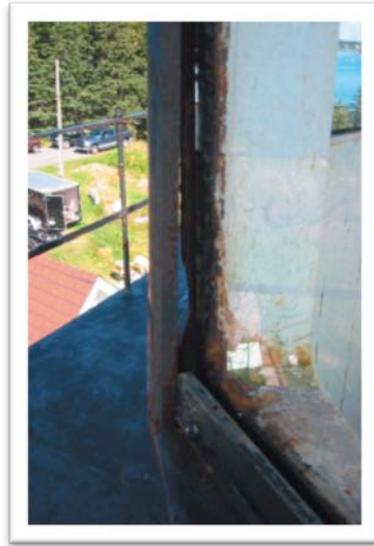
Repairing the metal work around the windows was demanding and technically difficult. The photo on the left shows corrosion on the astragals (vertical metal strips on the exterior used to secure the glass panes). Inappropriate caulking is also visible in this photo. The photo on the right shows an astragal improperly installed, leaving an air gap that allowed water intrusion, causing corrosion and failure of the framing.

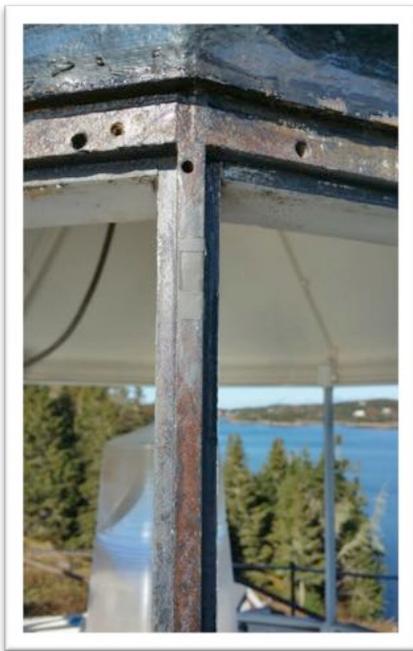
The photo to the left shows part of the window framing stripped of rust and failing paint, ready for repair and closing up of unneeded drill holes. The photo below shows damaged and broken astragals awaiting repair.

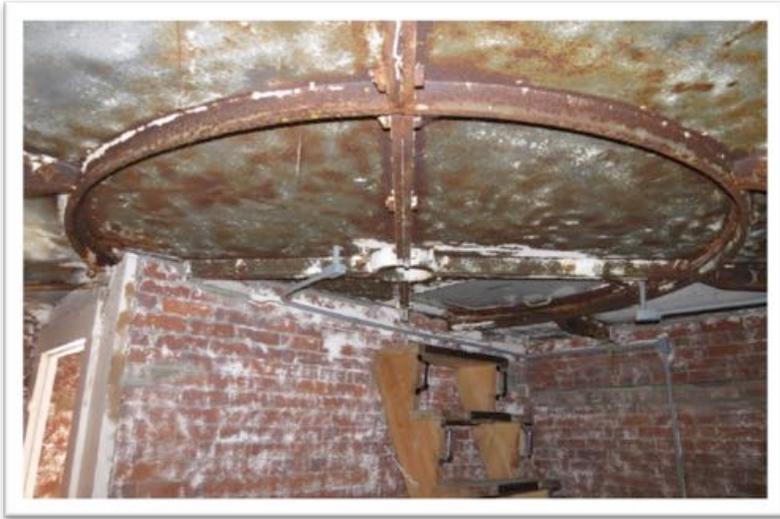
The Watch Room is immediately below the lantern room. The base of the cupola forms the ceiling of the watch room. It is the circular structure seen in this photo. It was contaminated with rust and lead paint.
