# Historic Building Architects, LLC

Re: Burnt Coat Light Station, Swan's Island, ME

2. Light Station Tower Assessment: We were asked to assess the condition of the Light Station Tower comparing the current conditions to our survey in 2006 and have provided a series of annotated photographs. The hope is that this will help the Friends of Swan's Island Lighthouse (FOSIL) to enroll the support needed for the Tower restoration, which is clearly becoming increasingly urgent.

Tower Conditions at  
Swan's Island Light Station

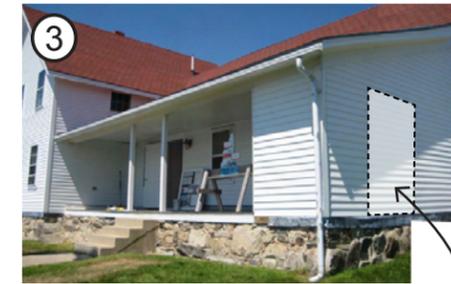
Above: New Viewport (door) at Piazza east end would replicate the door to the covered connection (since removed) to the Tower.

In addition to providing a view south from the Piazza, we also recommend considering recreating the door opening on the east gable, which originally provided a covered 'lean-to' shed connection to the Tower entrance. This door could be opened in summer and allow barrier-free visitors to view close up the Tower from the Piazza. The shed connection was removed in the 1950s, and we do not recommend reinstalling it because closing off this east side of the building would significantly hinder circulation around the building due to the already steep slope on the west end of the Light Keeper's House. Barrier-free access into the tower is not feasible due to the narrow opening in the thick masonry wall and the interior configuration of the stairs within the tower.

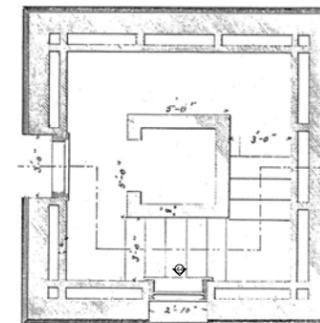
Left: Plan of Tower, showing tight interior stair layout that makes barrier-free access infeasible.

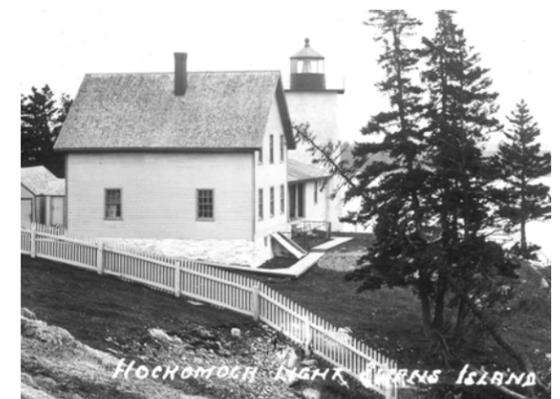
The existing concrete path is extremely uneven and unstable and we recommend addressing this in the near future, especially now that the entrance path has been created, which encourages ambulatory visitors to access the steep west side of the Light Keeper's House. Historically, wood decking was used to access this side of the house, as seen in the historic image to the right.

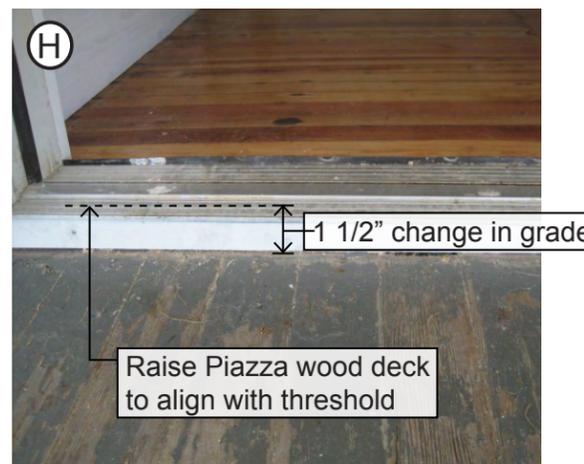
**Piazza Entrance Door (D101-A)**

This door was replaced in 2010 with a 6-panel solid wood door. The previous door in this location, as noted in Section 5, page 3 of the Preservation Plan was a 6-panel door with 3 glazing units in the top panel. The door frame and threshold were all in poor condition, and it is suspected that the door was not the original to this opening. Similar to D104-A, we believe the 6-panel solid wood door does not detract from the architectural significance of the building since no evidence can be found that the original was a 4-panel door. MHC should provide an opinion on whether this door should be replaced with a 4-panel door similar to the Door D102-A. The hardware should be replaced, as described above for D104-A. The threshold is aluminum (photograph H) and does not provide barrier-free access because of the existing level change of 1 1/2". The floor deck of the Piazza needs to be temporarily removed to provide access for framing repairs below. At that time, we recommend raising the Piazza wood floor and installing a painted or stained wood threshold to allow for barrier-free access. See Drawing A 1.4.

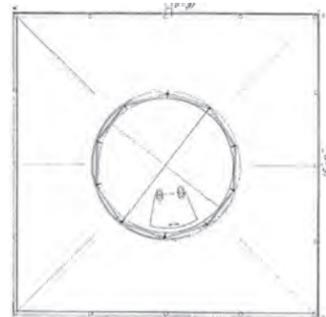
Plan of Lantern

- 1. Significant increase in corrosion.
- 2. Railings likely to have imminent failure.
- 3. Base of lantern drum allowing water ingress into Tower at ceiling.

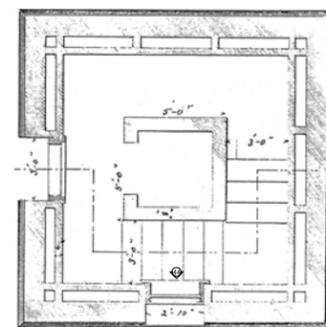
Plan of Tower

1. Trapped moisture has resulted in increased corrosion and rust jacking.
2. Ventilation system no longer operable.
3. Masonry being compromised by rust jacking.
4. Moisture ingress due to failed exterior paint.

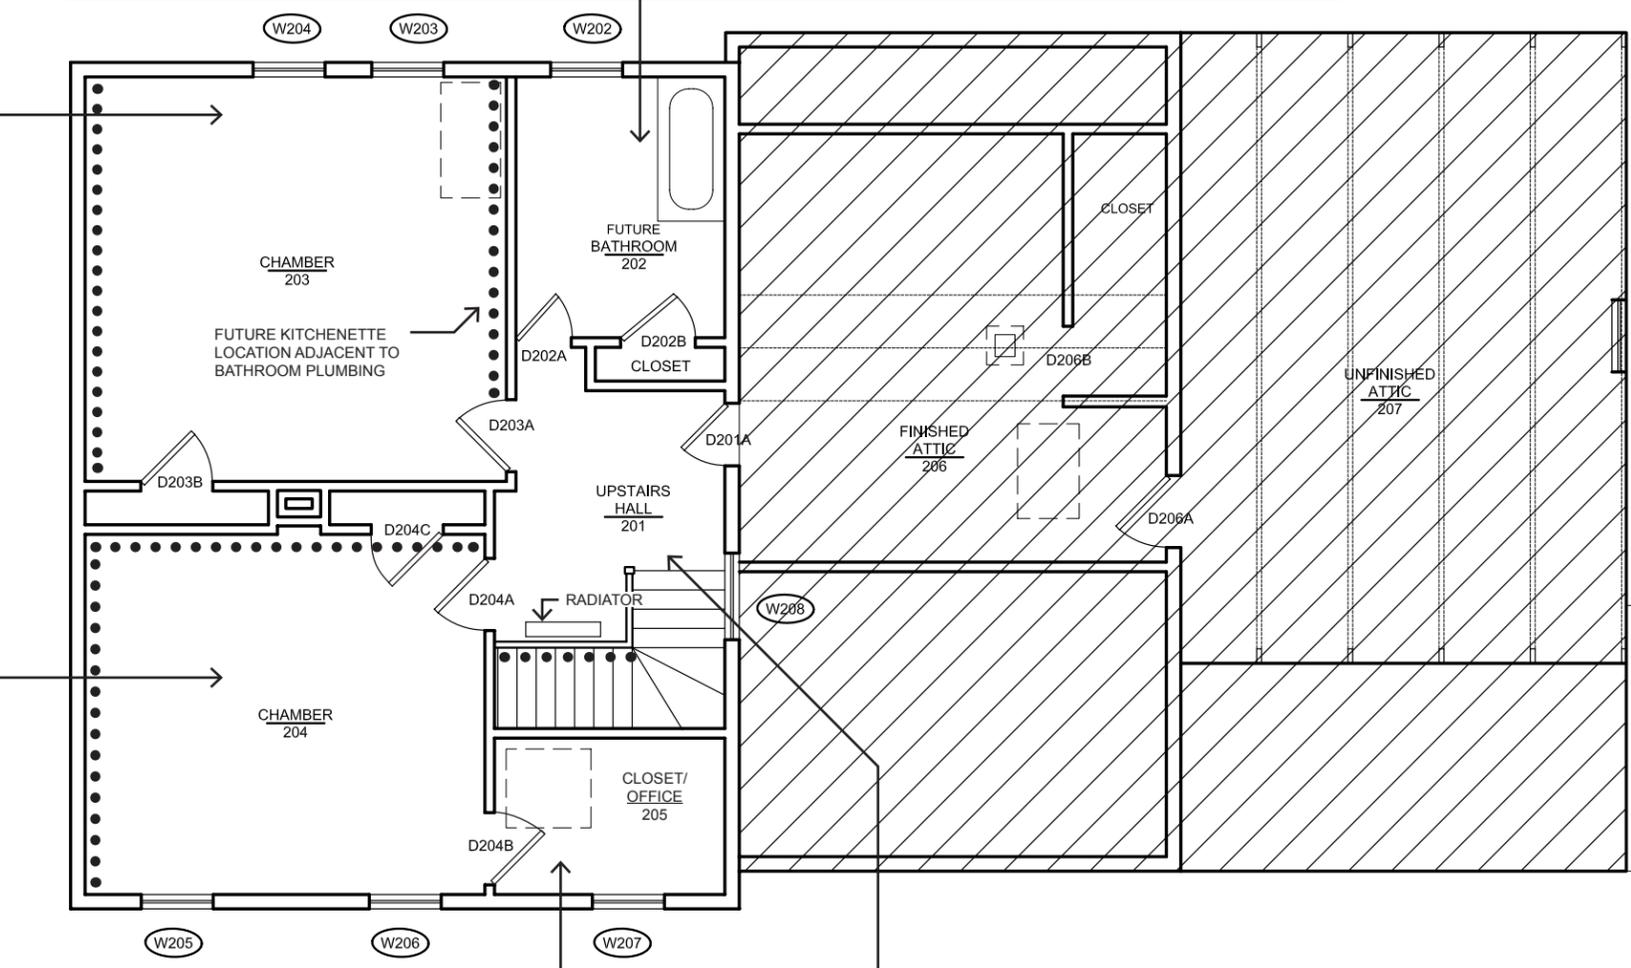
**Future Bathroom - Room 202**  
 Floor: The red paint color on original wood boards to be used on floor. Repair existing wood floor board. Sand, prime, & paint.  
 Walls: Replace deteriorated plaster & lath with new veneer plaster over gypsum wallboard (100%).  
 Ceiling: Replace deteriorated plaster & lath with new veneer plaster over gypsum wallboard (100%); include flat & sloped ceilings.  
 Special Notes:  
 Refinish bathtub & reinstall (optional). Replace D204A with new 4-panel to match historic. Existing doorknob on D 202B good match for new replacement doors.

**Chamber - Room 203**  
 Floor: Remove vinyl flooring. Restore wood floor boards. Repair, sand, prime & paint.  
 Walls: Restore existing plaster at East & West walls. Replace remaining walls with veneer plaster on GWB.  
 Ceiling: Replace ceiling lath & plaster with new veneer plaster over GWB; include flat & sloped ceilings. Install new appropriate lighting.  
 Special Notes:  
 D203A - Replace existing door with new 4-panel to match historic (example D202B).

**Chamber - Room 204**  
 Floor: Remove contemporary vinyl floor covering. Sand & paint original wood floor boards.  
 Walls: Restore North & West wall plaster finish. Replace south & east wall plaster & lath with new veneer plaster over GWB.  
 Ceiling: Replace ceiling lath & plaster with new veneer plaster over GWB; include flat & sloped ceilings. Install new appropriate lighting.  
 Special Notes:  
 D204A - Replace existing door with new 4-panel to match historic (example D202B). Remove paint & biological growth on exposed brick chimney. Install new electric outlets in baseboard.

**Closet/Office - Room 205**  
 Floor: Strip, prime & paint existing wood flooring. Alternate: install removable floor cover without damaging existing floors.  
 Walls: Replace all plaster walls with plaster veneer over GWB.  
 Ceiling: Restore access hatch to functioning condition.  
 Special Notes:  
 Strip & paint all trim. Replace Doors D204A, D204B & D204C w/ new doors to match D201A.

**Hall - Room 201**  
 Floor: Remove plywood & restore 4" wide wood floor boards. Prime & Paint.  
 Walls: Retain samples of wall papers & exhibit. Restore 3-coat plaster wall at stair. Replace all other plaster with new veneer plaster over GWB.  
 Ceiling: Replace ceiling with veneer plaster over GWB; replace 100%.  
 Special Notes:  
 Stair Treads & Risers - Strip & paint.  
 Balusters - Lightly sand, prime, & paint.  
 Decorative Radiator - Strip, Prime & Paint (Not proposed for use; exhibit only)
