HAZARDOUS MATERIALS IDENTIFICATION REPORT

***SWAN'S ISLAND LIGHT HOUSE COMPLEX
SWAN'S ISLAND, MAINE***

Town of Swan's Island
Swan's Island, Maine 04685

Summit Environmental Consultants, Inc.
8 Harlow Street, Suite 4A
Bangor, ME 04401

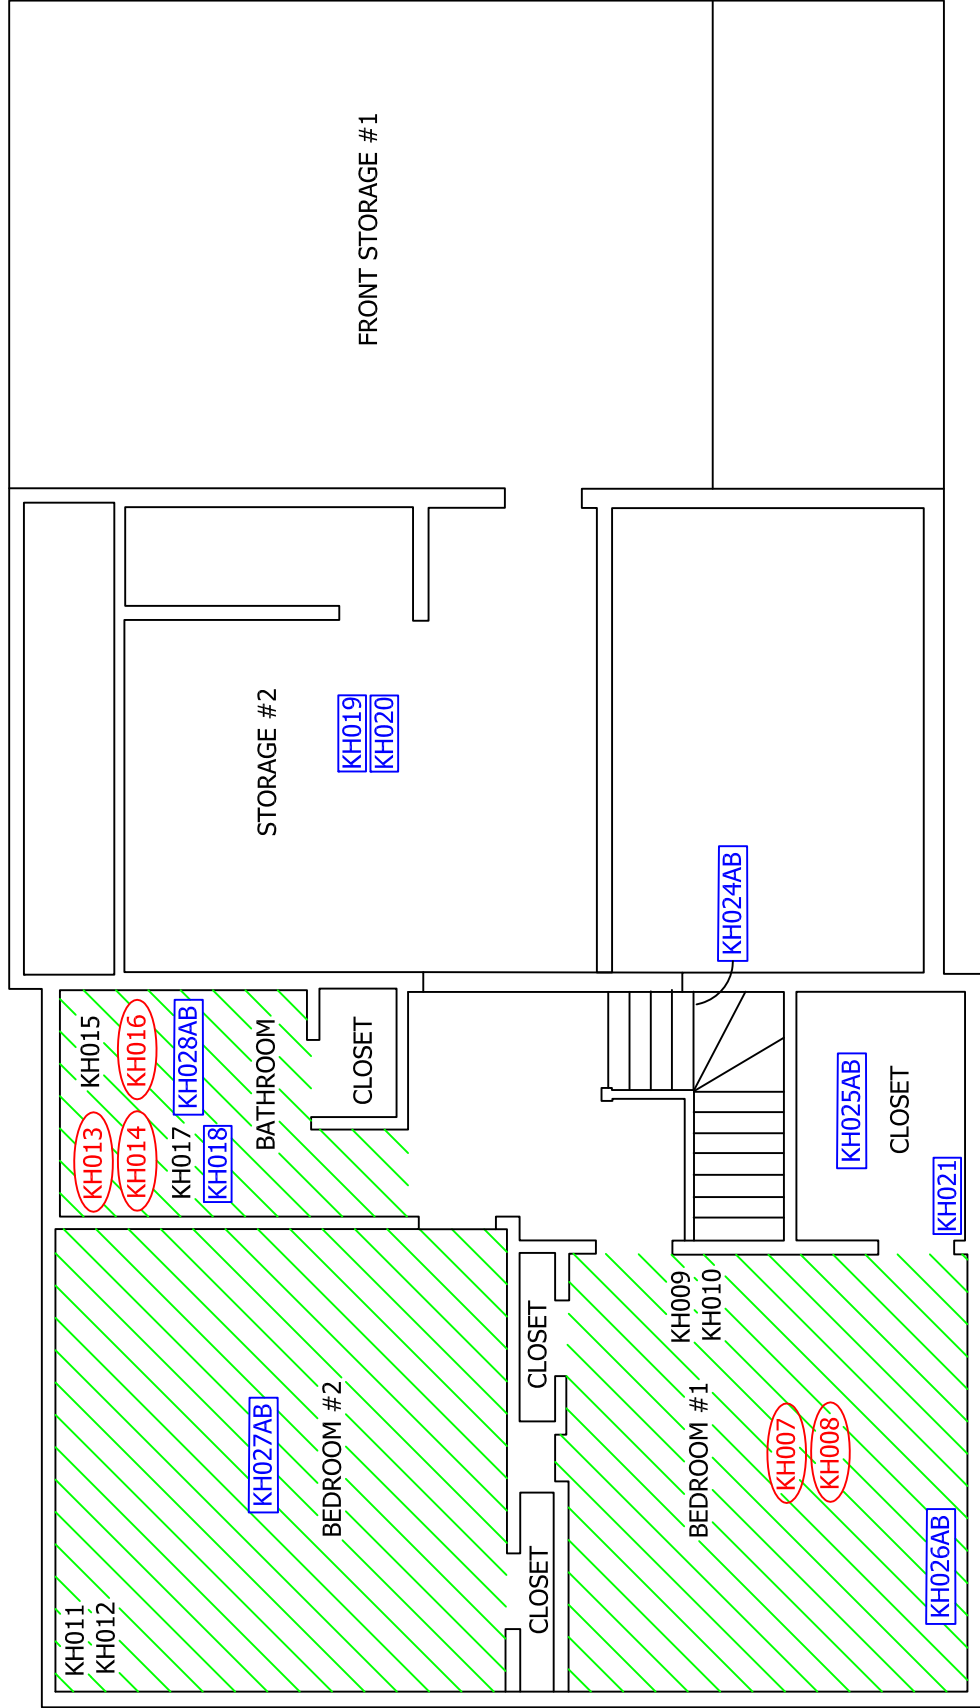
= ACM CEMENTITIOUS PANEL
KH009	= SAMPLE NUMBER AND LOCATION NOT ANALYZED (POSITIVE STOP)

KH001 = SAMPLE NUMBER AND LOCATION TESTING POSITIVE FOR ASBESTOS
